03—015 Refacing crankcase parting surface

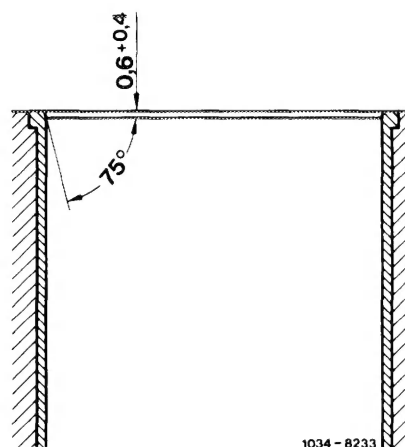
Height of crankcase as new		242.9–242.8
Minimum height after necessary stock removal		242.5
Permissible irregularity of parting surface	lengthwise	0.10
	crosswise	0.05
Permissible roughness of upper parting surface		0.006–0.016
Permissible parallel misalignment of upper to lower parting surfaces in lengthwise direction		0.1
Air testing pressure in water at bar positive		1.4
Cylinder bore chamber		see note
Gap between piston crown and crankcase parting surface	Engines 615.913/940	+0.65 to +1.05
	Engines 615.912/941, 616, 617	+0.50 to +0.90

Prior to refacing, be sure to check piston projection. This must not exceed 0.9 and 1.05 mm, respectively (03—316).

After refacing, be sure to chamfer cylinder bores.

If crankcase parting surface has been refaced, valve timing will need re-adjusting (05—215).
